Manhole Inspection Summary

Manhole # S29QQ_002MH

Insp Date: **6/19/07 9:45 PM**

Location Address: **2601 FALLS RD**

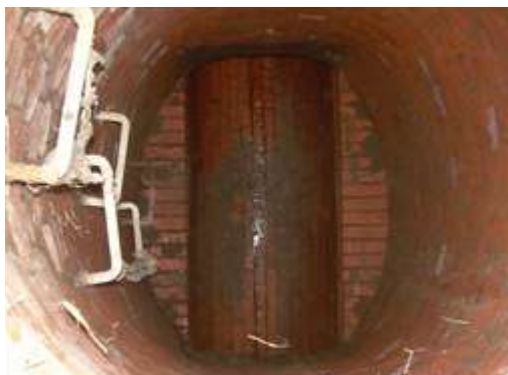
Top View

Steps Count: **5** Missing: **0** ☒ **Corroded**

Surcharge ☒ **Evidence Of Surcharge** Depth: **3** (ft.) ☐ Active Surcharge Present

Corroded steps. Evidence of surcharge - Bench debris.

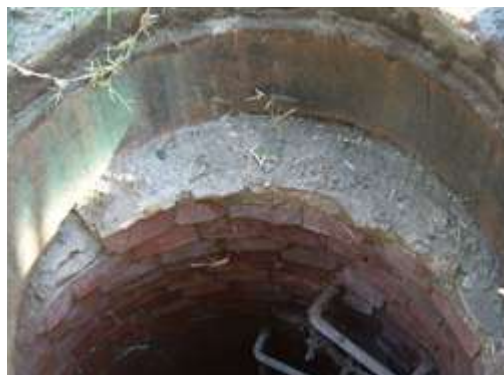
Frame Offset: **6** (in.)

Infiltration: ☐ None ☒ **Joint** ☐ Cracks ☐ Mortar ☐ Roots ☒ **Wall**

Frame offset. Corbel and Barrel infiltration.

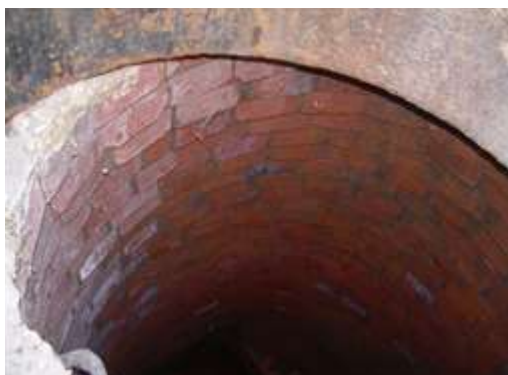
Corbel and Barrel infiltration.

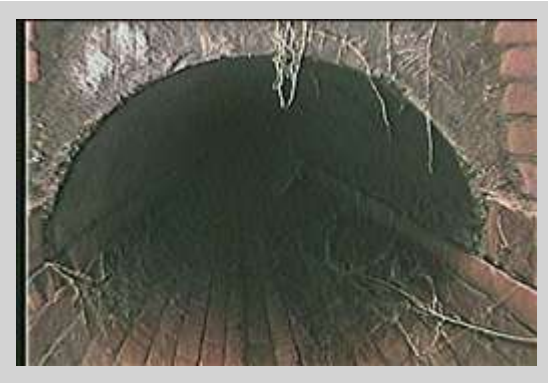
27 in. Circular Gravity Sewer Pipe Out @ 12 O'Clock

Barrel root intrusion and infiltration.

Infiltration: **Evidence** Pipe Seal Cond: **Roots**

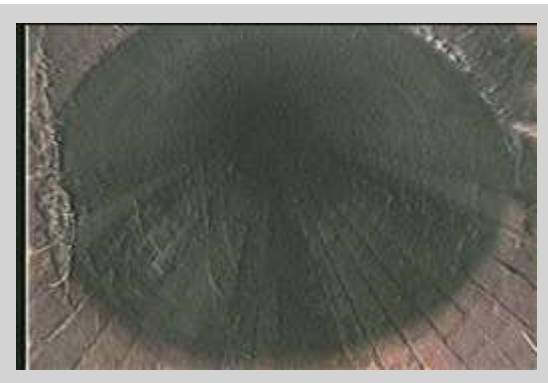
27 in. Circular Gravity Sewer Pipe In @ 6 O'Clock

Infiltration: **Evidence** Pipe Seal Cond: **Roots**
